BRISTOL FISH AND GAME CLUB DAM
CT-00299

PHASE I INSPECTION REPORT

NATIONAL PROGRAM OF INSPECTION OF DAMS

Name of Dam:	BRISTOL FISH AND GAME CLUB DAM
Inventory Number:	CT 00299
State:	CONNECTICUT
County:	NEW HAVEN
Town:	WOLCOTT
Stream:	CUSSGUTTER
Owner:	BRISTOL FISH AND GAME CLUB
Date of Inspection:	APRIL 29, 1981
Inspection Team:	PETER M. HEYNEN, P.E.
	MURALI ATLURU, P.E.
	JAY A. COSTELLO

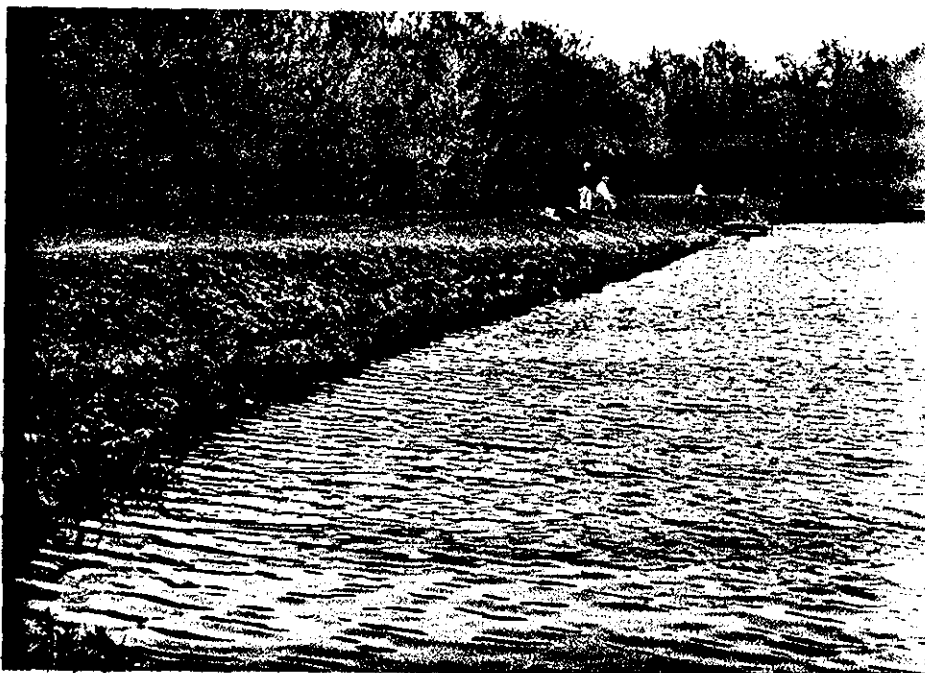
Photo 1 - Upstream slope from left abutment. Minor sloughing of the upstream slope is occurring at the waterline. Drop inlet can be seen at center of dam (April, 1981).

2. Regrading of the upstream slope and placement of sufficient riprap to protect against erosion and sloughing of this slope by wave action. This riprap should be placed between expected high and low water elevations, and should extend around the right end of the embankment to protect against erosion should the emergency spillway be activated.
3. Repairing spalled concrete at the sides of the riser structure hood, along the waterline where water enters the drop inlet.
4. Removing trees to a distance of 10 feet from the toe of the dam with proper backfilling and replacement of protective cover.
5. Elimination of burrowing animals in the embankment, backfilling the burrows and replacement of protective cover.

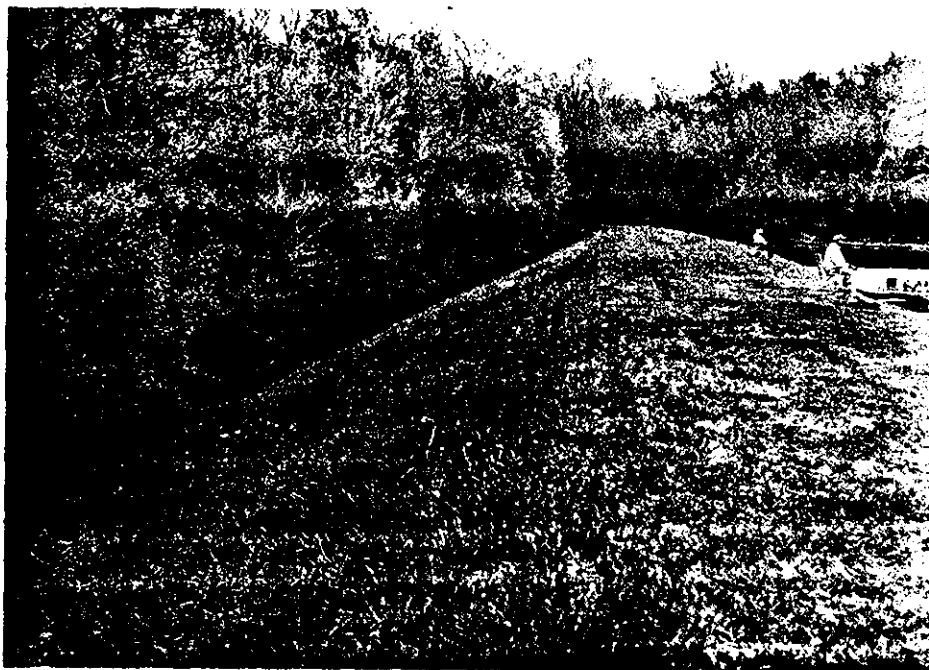
Photo 2 - Top of dam and downstream slope from left abutment (April, 1981).

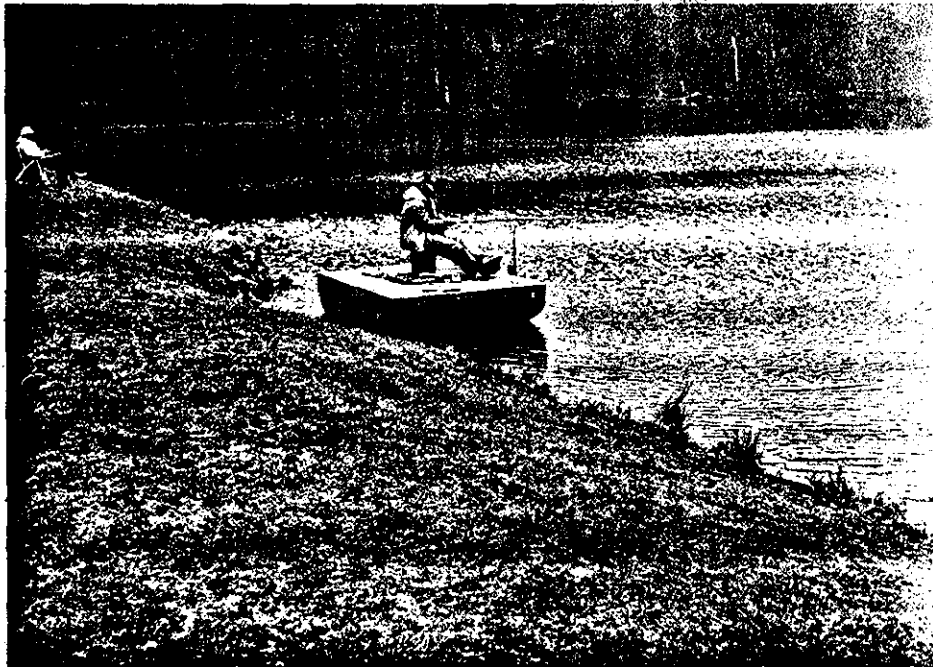
Photo 3 - Top of concrete riser structure. Casing for low-level outlet valve stem is located on upstream side of riser (April, 1981).

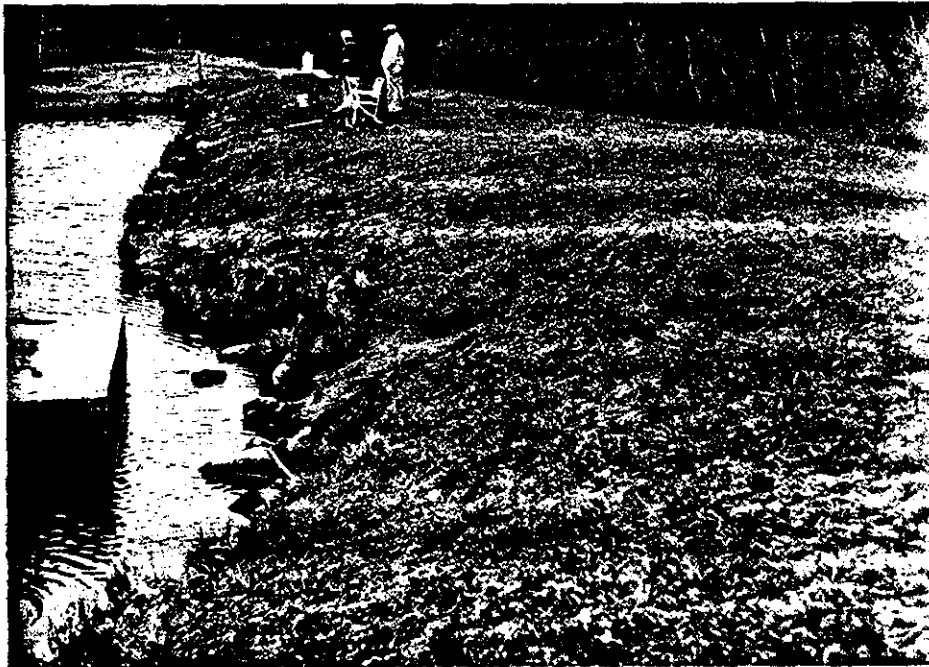
Photo 7 - Erosion and sloughing of upstream slope near drop inlet. Note sparse riprap at waterline (April, 1981).

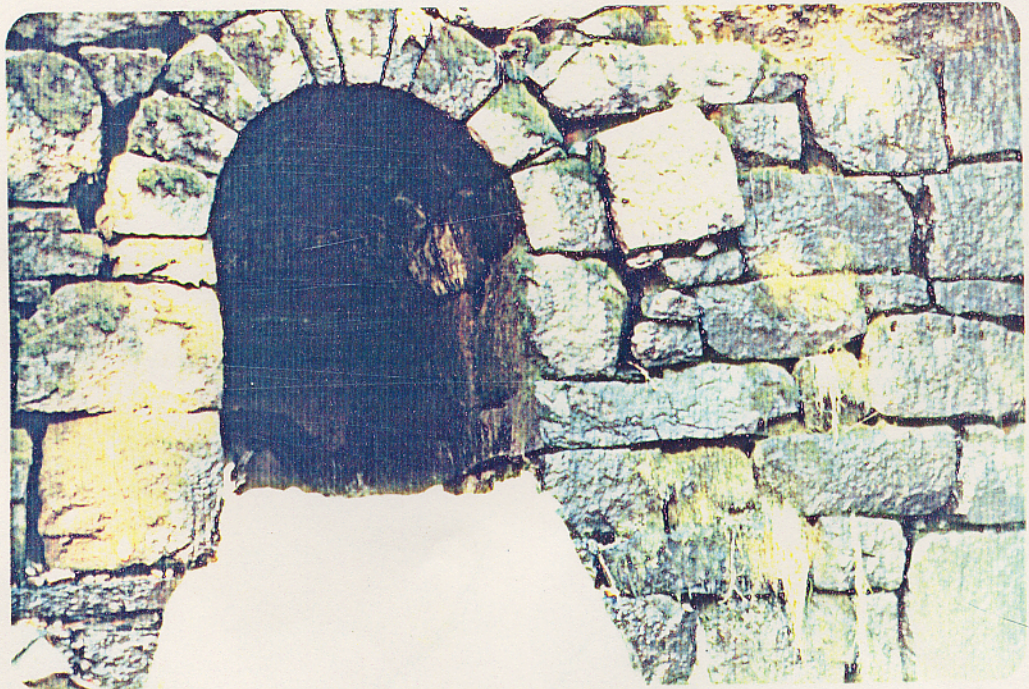
PHOTO NO. 2

STONES MISSING IN ARCH ROOF,
BLOCK POPPING OUT LEFT OF OUTLET
WOODEN MEMBERS SUPPORTING UPSTREAM ROOF

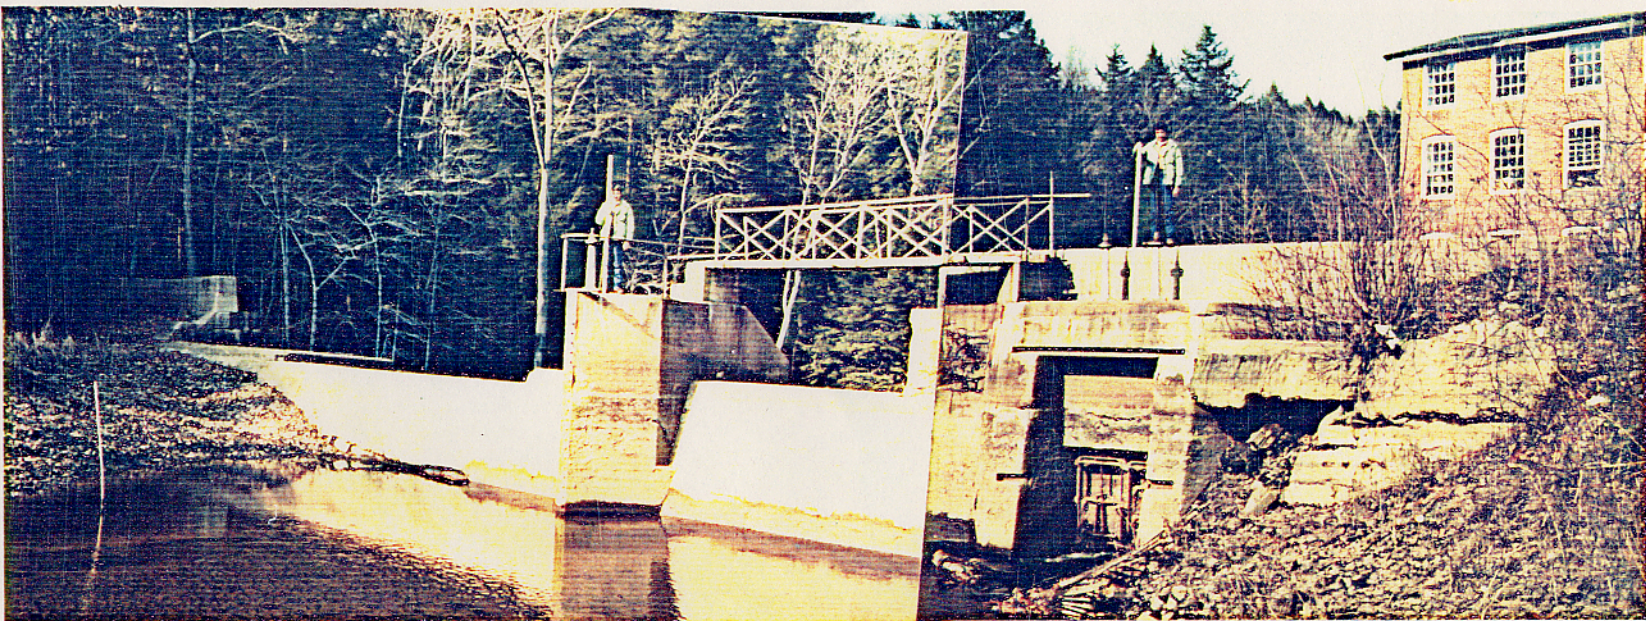
PHOTO NOS. 3 & 4

UPSTREAM FACE AND INTAKE

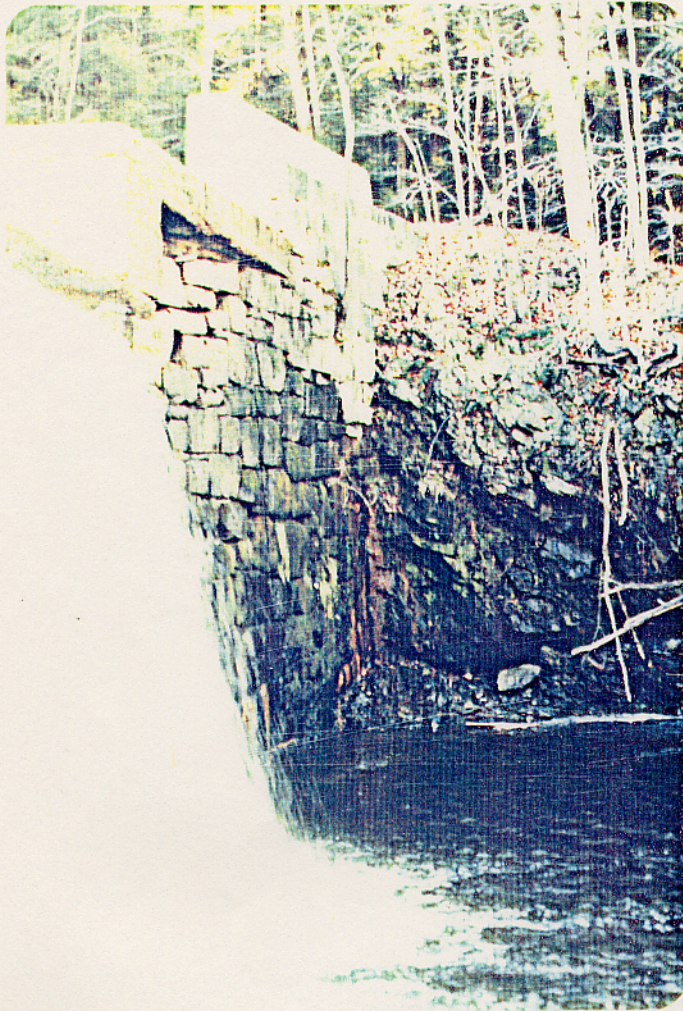
PHOTO NO. 5

TREE GROWING FROM STONE
MASONRY ON LEFT SIDE OF DAM

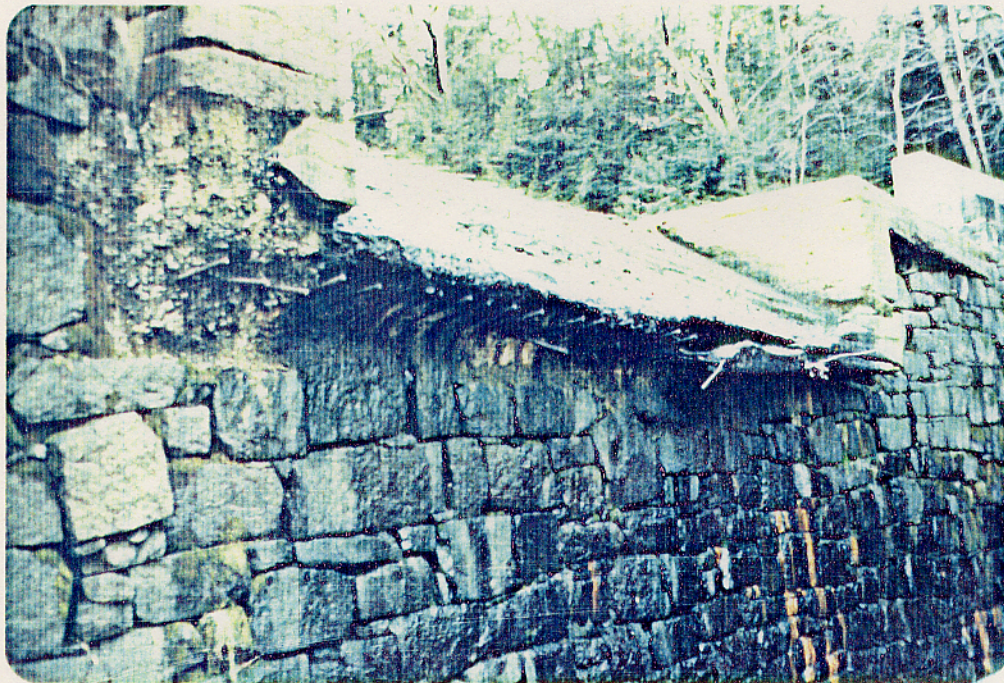
PHOTO NO. 6

DETERIORATED
CONCRETE ON
SPILLWAY SLAB

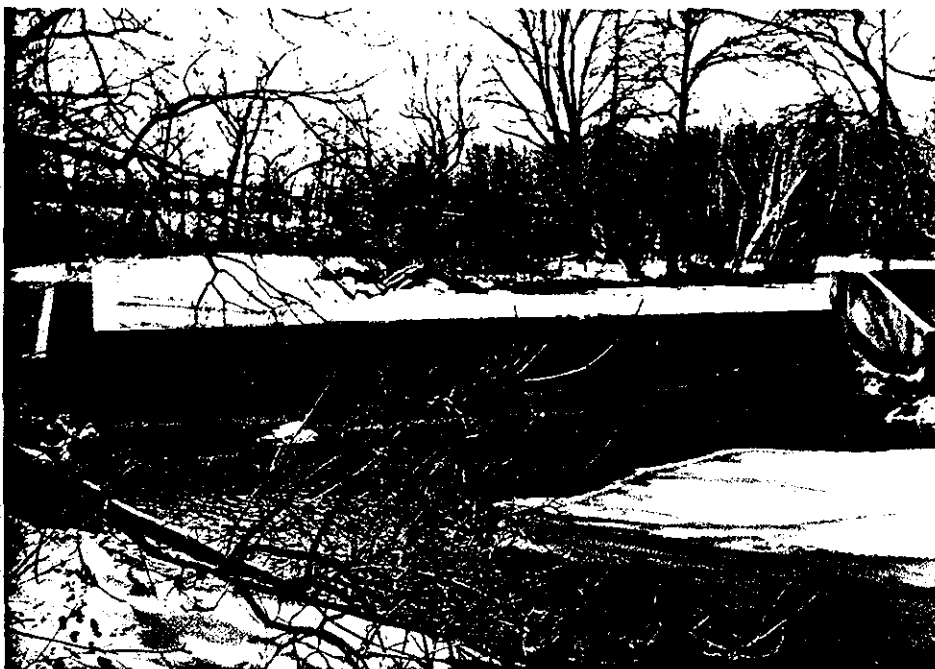
Photo 2 - View of spillway from bridge.
Note outlet works on left edge
of spillway.

It is recommended that the owner repair the wooden sluice gate and the winch mechanism of the regulating outlet within one year of receipt of this report. Other remedial measures contained in Section 7 should also be carried out within a period of one year.

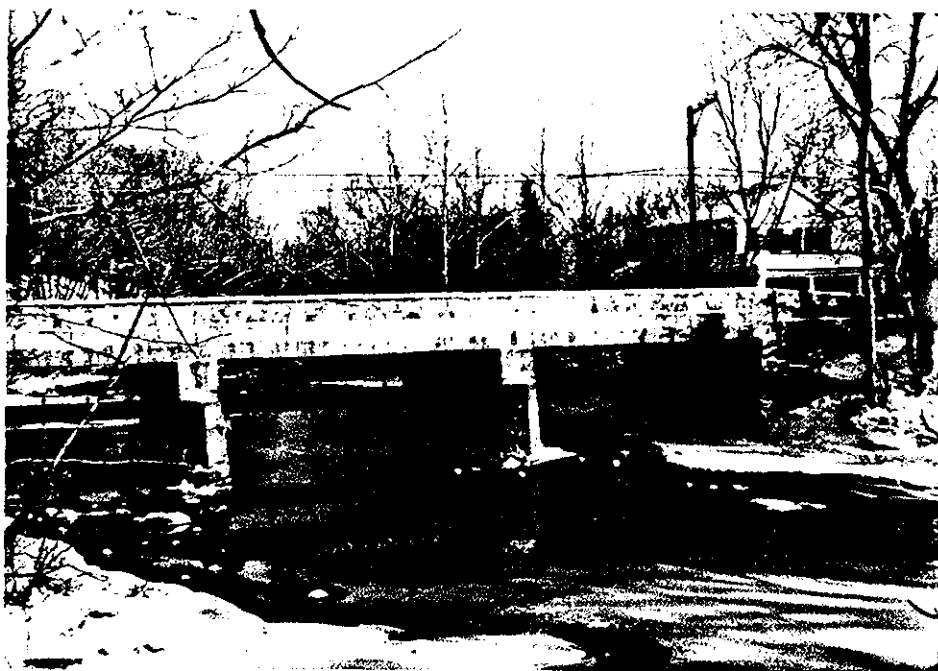
Photo 8 - View of highway bridge and downstream channel (Stoney Brook). Note utility pipe suspended under bridge.
